Windowcraft – Part One

SONJA ALLBÄCK AND BERTIL FREDLUND

Abstract

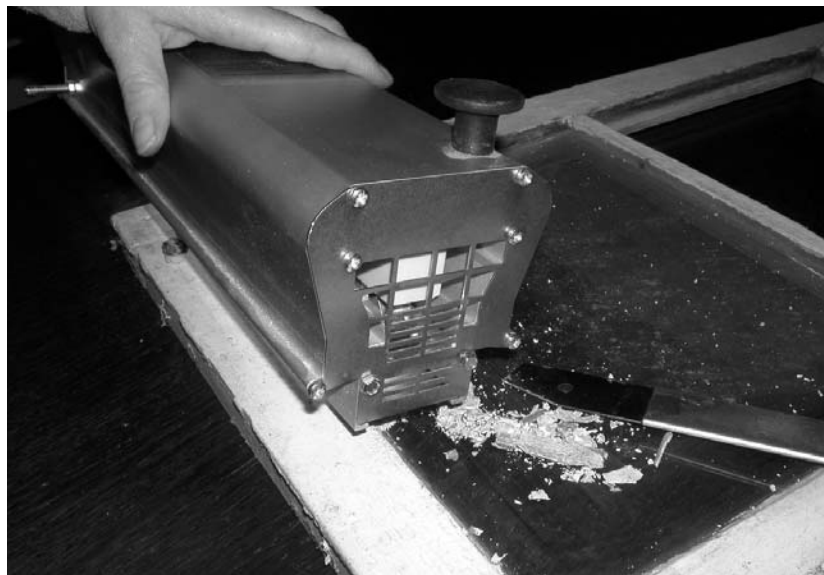
Another difficult problem that we encountered was how to soften hard linseed-oil putty in order to remove glass. The putty needs to be heated to more than 100°C to soften (depending on the quality of the putty), but glass will crack long before that temperature. As we wanted to save the old blown glass in order to recycle all parts of the window, we carried out many trials before realizing that infrared radiation with a wavelength

below $2.6\ \mu\text{m}$ passed through the glass. At a wavelength of $2.0\ \mu\text{m}$, only 10–15 per cent of the energy is absorbed by the glass, depending on its thickness and iron oxide content. We knew that if we could regulate power to the lamp at a level where the infrared radiation was very high ($\sim 2.0\ \mu\text{m}$) and focus this energy, we might heat the surface without affecting the glass. This was the basis for the development of a new tool to soften hard putty without cracking the glass – the ‘putty lamp’ was born (Figure 2).² Infrared radiation passes through the glass, and softens the putty over and under it. Once the putty and pins are removed, the valuable, original glass can be lifted from the casement and recycled.

Figure 2 The putty lamp – an innovation by Sonja and Hans Allbäck.

- 1 For further information on Windowcraft, see: www.windowcraft.se.
- 2 The putty lamp uses a tungsten filament, which operates at a temperature of 700–1,700°C to produce infrared radiation of wavelength $\sim 2.0 \mu\text{m}$.
- 3 Simmons, C., *Fönster med hög ljudisolering mot trafikbuller (Windows with Good Noise Reduction against the Traffic Sound)*, Rapport 1998–26, Sveriges Provnings-och Forskningsinstitut (The Swedish National Testing and Research Institute) (1998).
- 4 Nordiska Museet, *Var virket bättre förr (Was Timber Better in the Old Days?)*, The Nordic Museum (1985).
- 5 Sjömar, P., *Byggnadsteknik och Timmermanskonst (Building Techniques and the Art of the Carpenter)*, Chalmers Tekniska Högskola (Chalmers Institute of Technology) (1988), pp. 208–11.
- 6 Rolandsson, A., Market Communication Manager, Pilkington Sweden (personal communication).

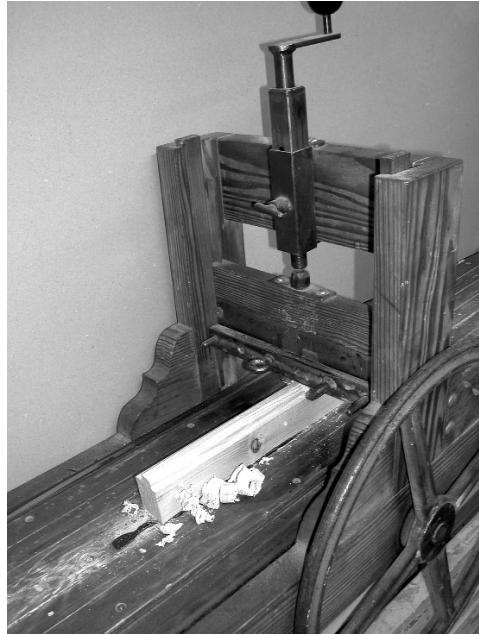
Figure 3 Modified copy of a planer from the early eighteenth century.

We also found many useful hand tools and quality materials, including a hand-driven profile planer from the early eighteenth century. Even today we use this ‘machine’ to complement the work of modern machinery in renewing windows from that period (Figure 3).

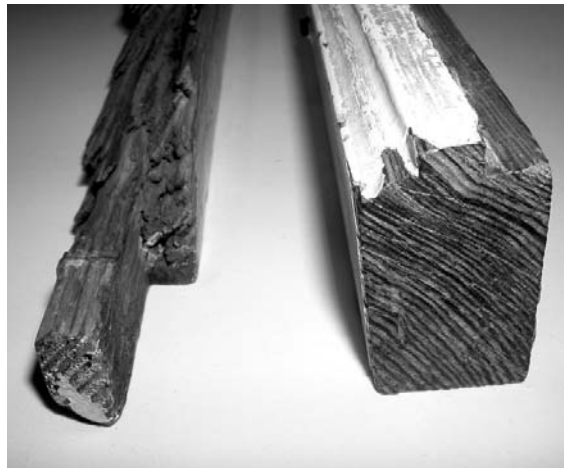
Figure 4 Window sections 15 years old (left) and 150 years old (right).

After the Second World War, people disregarded quality and ignored the lessons of the past. Today we have many problems with windows and doors that are no more than 10 or 15 years old (Figure 4). In order to save as much of the older, good-quality material as possible, we have rediscovered simple techniques for repairing sashes and frames. We use

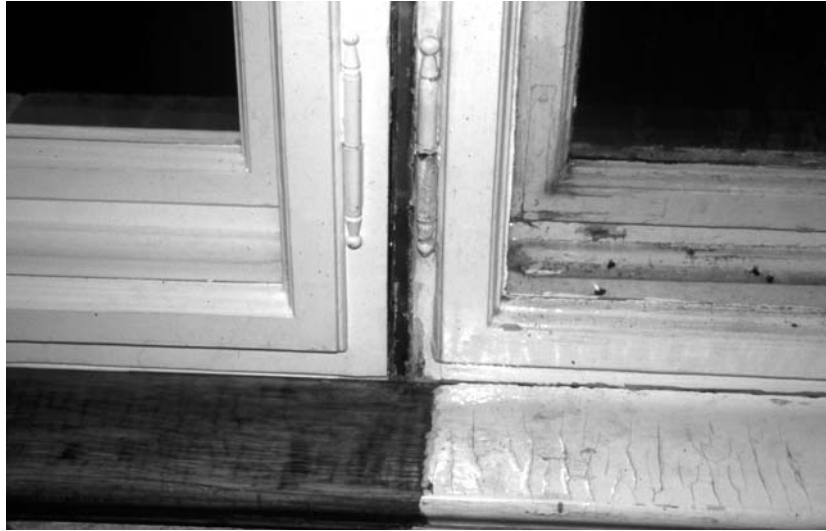
Figure 5 Window from 'Kastenfenster' in Leipzig dating from 1880.

The window from August Bebel-Strasse consisted of an inner and outer frame with three inward-opening inner casements and three-inward opening outer casements (Figure 5). The casements did not have cross bars, nor were there any fittings on the outside.

All the frames and casements were of very good quality and well worth preserving. The timber was healthy and there was no fungal damage. In spite of neglected maintenance, the windows were in good condition.

The casements and frames were dismantled and transported to our workshop in Ystad, Sweden. First, all the glass was removed with a putty lamp. Rusty fittings were removed for cleaning and all paint was

completely removed. The outer and inner frames were fitted together and minor damage caused during transportation was repaired. After impregnation with raw linseed oil, the windows were re-glazed using linseed-oil putty of our own manufacture. Our goal was to keep the milled glass in the outer casements. As an experiment, we used 3 mm Pilkington Kappa Energy glass (K-Glass) in one of three inner casements, in order to show the differences in colour and light. Nobody noticed the difference.
